**Saskatchewan Land Surveyors' Association
Survey Project # 1 – Restoration/Re-Establishment**

Brian Burridge, SLSIT

For: SLSA Board of Examiners

February 28, 2007

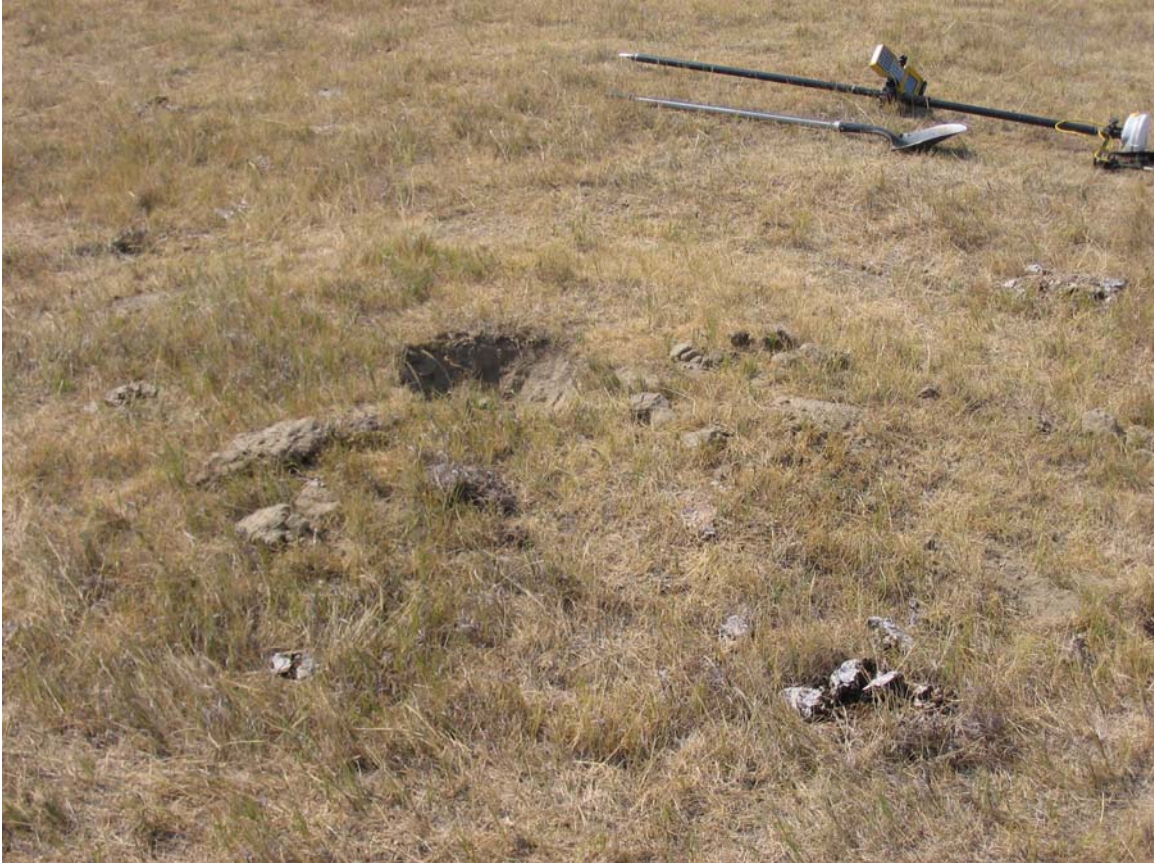
As mentioned previously, Mr. Hogg's plan notes re-establishing a monument at the actual NE 19-12-25 W3. Because of this, another visit was made to this corner, and a

significant dig was performed in the lake bed to see if anything would turn up. This search resulted, once again, in no evidence of a monument ever being there. Photos of the NE 19-12-25 W3 can be seen below.

Figure 3.1 – Trench found at the NE 19-12-25 W3

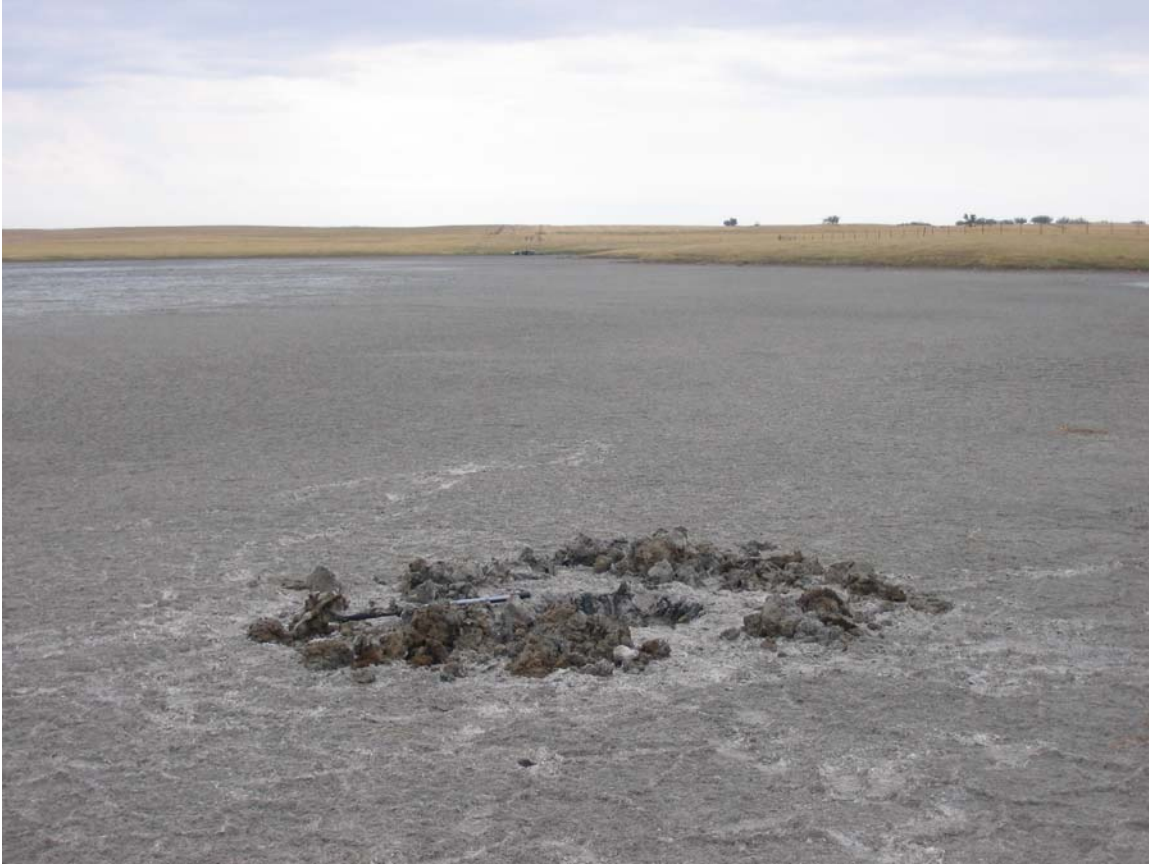
Figure 3.2 – Location of the NE 19-12-25 W3; Facing South

An iron post found at NE 30-12-25 W3 Mer and an iron post found at E 18-12-25 W3 Mer were connected to the survey so as to compare the established point at NE 19-12-25-W3 Mer using the witness trench, with the point that Mr. Hogg established. The difference between these two established points was actually within the standard of accuracy put forth by the Land Surveys Act 2000. However, with the witness trench governing the position of NE 19-12-25 W3 Mer, Mr. Hogg's method of re-establishing the monuments for the primary monuments between the NE 30-12-25 W3 Mer and the E 18-12-25 W3 Mer was not the proper method to use.

This project re-established these points using a different method. Using the witness monument, the position of the NE 19 was established. The position of the E $\frac{1}{4}$ 30

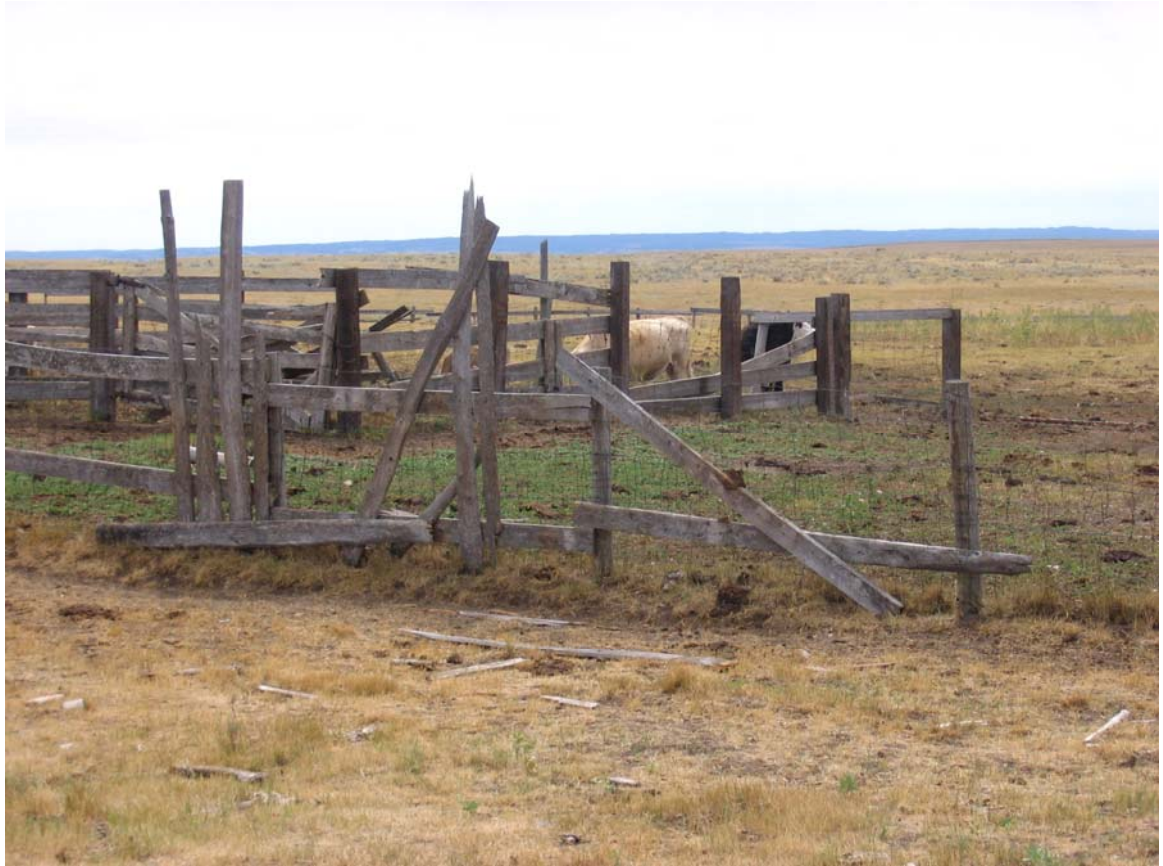
The last primary monument to be affected by this re-establishment was that at the N ¼ 20-12-25 W3 Mer. Mr. Hogg's plan showed that the monument planted at the time of the original township survey was lost. He, therefore, re-established this position and planted a monument at this position with his plan. With the position of the NE 19 changing, it was concluded, that a connection to the N 20 was needed to ensure that it was in fact in the right position. When this point was visited, the preliminary search resulted in no evidence of Mr. Hogg's monument being found. It should be noted that this point fell inside corrals, and therefore may have been disturbed with the construction of the corrals. Nonetheless, a significant dig was once again performed in attempt to find a rust hole left by the monument placed by Mr. Hogg. Once again, however, no rust was found. A photo of the N 20-12-25 W3 can be seen below.

Figure 3.3 – Location of the N 20-12-25 W3; Facing South

At this point, it was concluded that the position of the N 20 had to be re-established. Because Mr. Hogg's plan re-established this position, and it was the most recent determination of that position, his plan was to be used to re-establish the position once again.

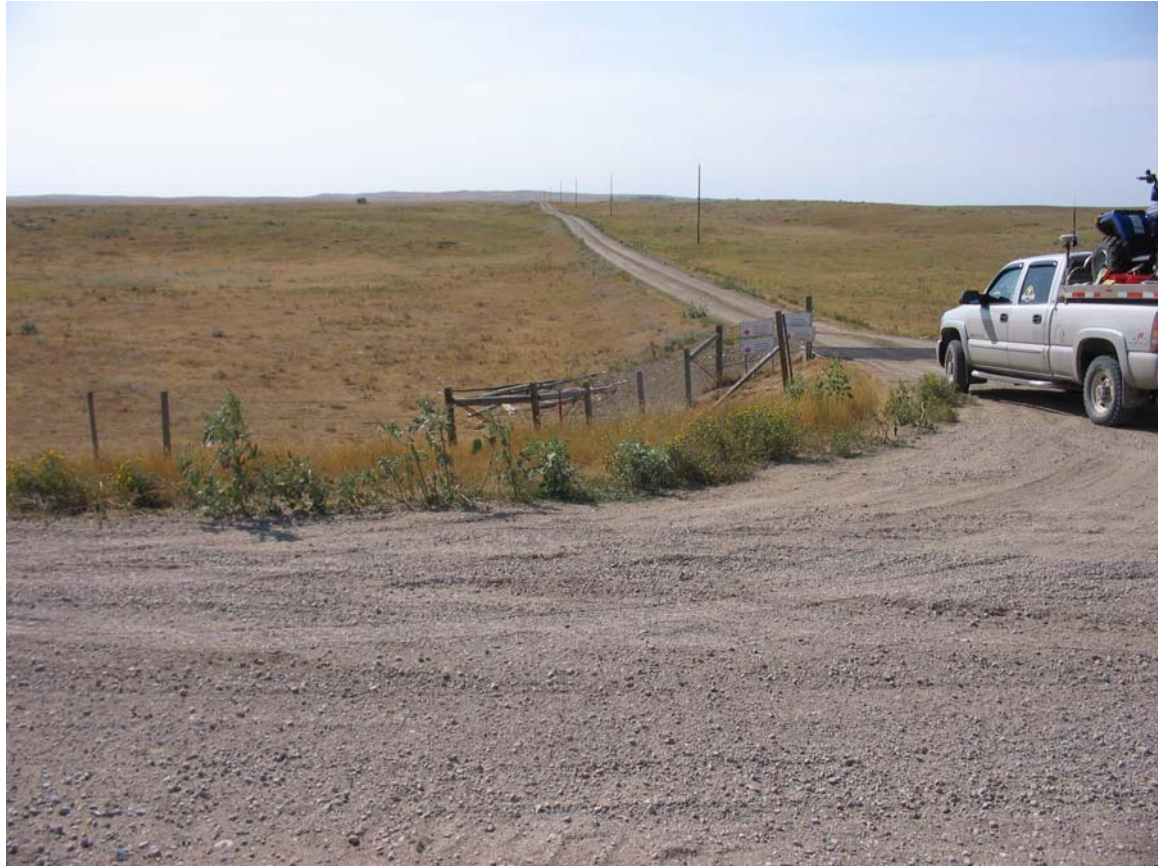
To do this, the position of the NE 20-12-25 W3 M needed to be determined. Mr. Hogg indicates, at the time of his plan, that he found evidence at this corner, and planted an iron post at that position. This corner was visited and it was found that, with the construction of the ditches for the high grade road, any evidence (including the monument) that had defined this corner was destroyed. A photo of the NE 20-12-25 W3 can be seen below.

Figure 3.4 – Location of the NE 20-12-25 W3; Facing West

So, the position of the NE 20 had to be re-established. This was done by observing road monuments along Mr. Hogg's plan. Specifically, the monuments marked 'R8' and 'R9' were observed. The reason for this was that Mr. Hogg shows an angular tie between the line formed by 'R8' and 'R9' and the north boundary of Section 20. Using this angle, and the distance shown between the monument marked 'R8' and the iron post that Mr. Hogg planted at the NE 20, the position of the NE 20 was established. Only a point was established at this position. No monument was planted here. Photos of the NE 20 can be seen below.

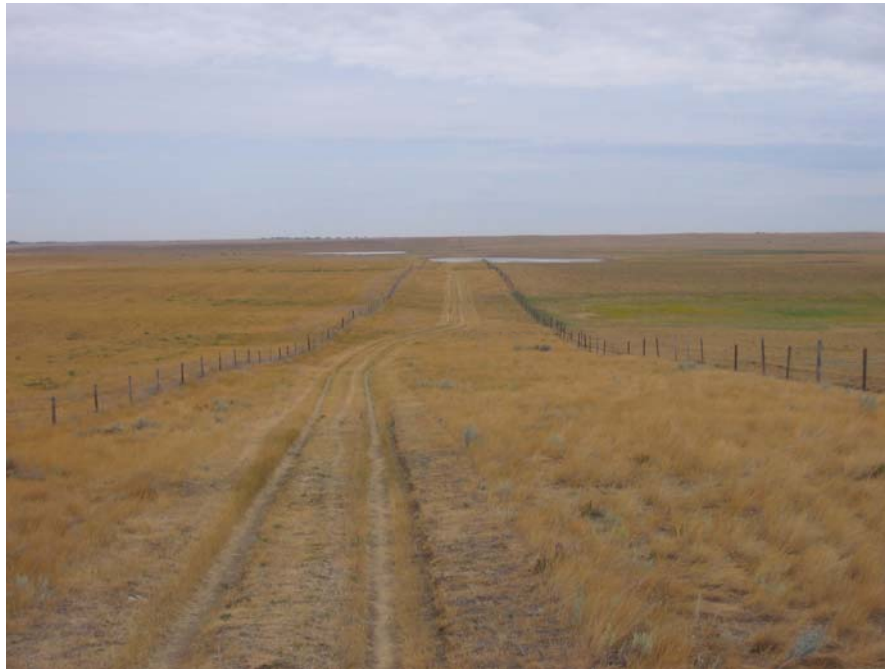
These things indicate the possibility that the descriptions given to the corners in question were transposed on the original road plan. As the NE 19 was found in a well established wet area, it was concluded that Mr. Hogg **did not** in fact place a monument at this corner during his survey because it was under water. As the NE 18 had a monument found marking its position on three separate occasions prior to this survey, as well as during this survey, and that the physical location of the NE 18 was on a well established high point, it was concluded that a monument **was** in fact placed there during the road survey by Mr. Hogg. This elevation change is displayed in the photo.

Figure 4.1 – Near the NE 18-12-25 W3; Facing North

To add to this confusion, the iron post found at the NE 18-12-25 W3M was in fact marked '1/4'. This was obviously the incorrect marking for the position it intended to
