**PROFESSIONAL SURVEY PROJECT II  
MUNICIPAL ROAD / CONSOLIDATION  
N. BOUNDARY 31,32,33,34-14-9 W2 Mer**

Jill Cheverie, SLSIT

Submitted to: Saskatchewan Land Surveyors' Association  
Board of Examiners

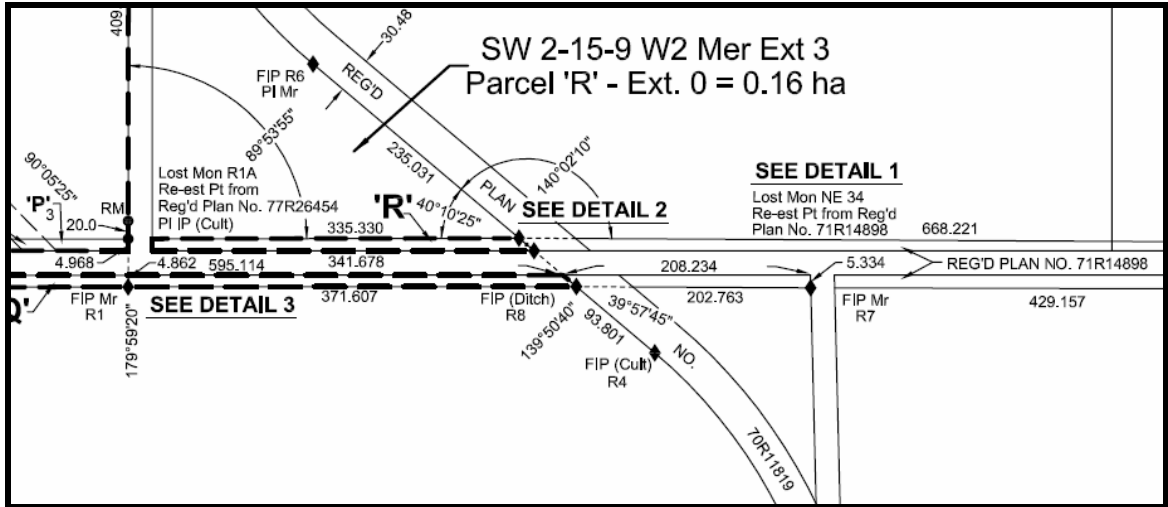
Figure 3.1: Portion of the Plan of Survey for this project.

There was disagreement at the eastern limit of this new road. This is most likely due to the intersection of three separate plans at this area (See Figure 3.1 below). The majority of the monuments involved in the intersection were found bent. The bent monument was exposed to the point where the bend became apparent. At this point the monument was rotated to loosen it and then pulled from the ground. A clear and solid 'downhole' could then be recognized and the monument was straightened and restored.

The overall distance between R6 and R4 along Registered Plan 70R11819 agreed with previous measurements. When R8 and R8A were found to be very close to this line, a confidence grew in this line. The major disagreement was found between R8 and R4. The measured distance was 93.801, however the plan distance taken from Registered Plan No. 70R11819 was 93.601. All measured angles in very close agreement with the plan. It seemed that over the years, this distance between R8 and R4 was avoided. The only time this distance was measured was on the original plan. This 0.2 m disagreement is probably why it was always avoided.

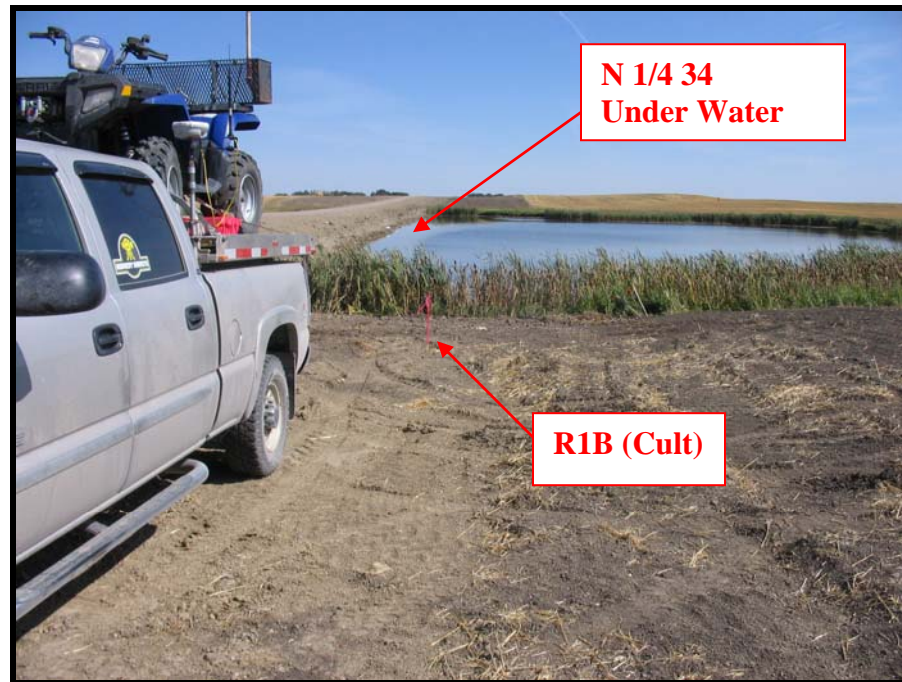
Figure 3.2: Picture of the N 1/4 34-14-9 W2 Mer

The established position of the north quarter section corner was under water (See Figure 3.2 above). This corner had been witnessed in previous years but was declared lost in Registered Plan No. 77R26454. Therefore in this case, R1B was established 110.000 meters west of the N ¼ 34 and on the right of way limit. It was then connected to the established position of the quarter corner.

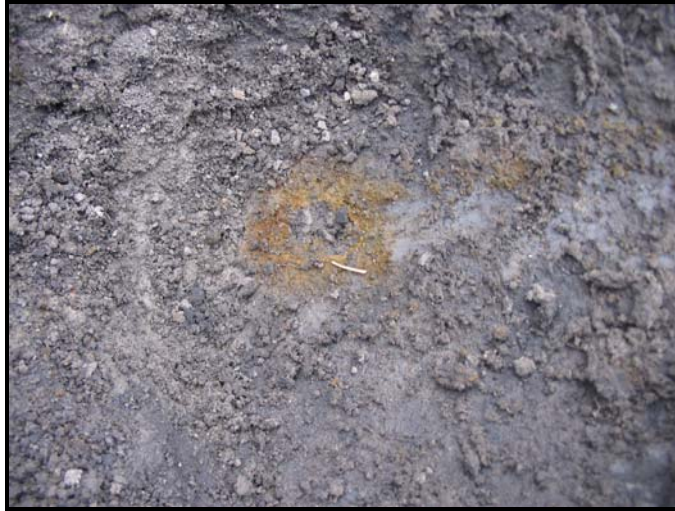
**Figure 3.4: IP Rust Hole found for R1, Registered Plan No. AO5523**

In order to confirm this position, more searches were done. All other monuments on this plan were declared as lost. However, an FIP was discovered further south on another road diversion, namely, Registered Plan No. AV3436. Once this FIP was connected to the east boundary of section 33, the resulting measurements would confirm the position of the rust hole. This plan is one the road diversion plans which is being recommended for abandonment as it is no longer being used.

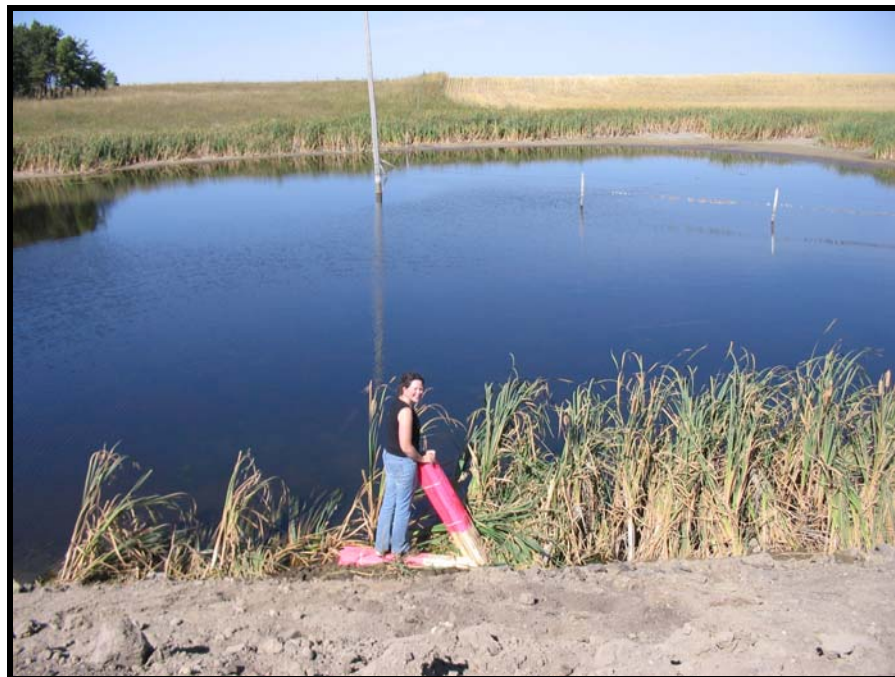
Figure 3.6: "A Bridge of Lath" to reach the iron post at the S 1/4 4-15-9 W2 Mer

One example was at the south quarter of section 4 (See Figure 3.6 below). In this case the quarter corner monument was found. The road monument could not be occupied as it was under deep water. The reference monument was established 70 meters from the established position of the road monument. The quarter line was a surveyed line and therefore the reference monument was established and monumented on this line.

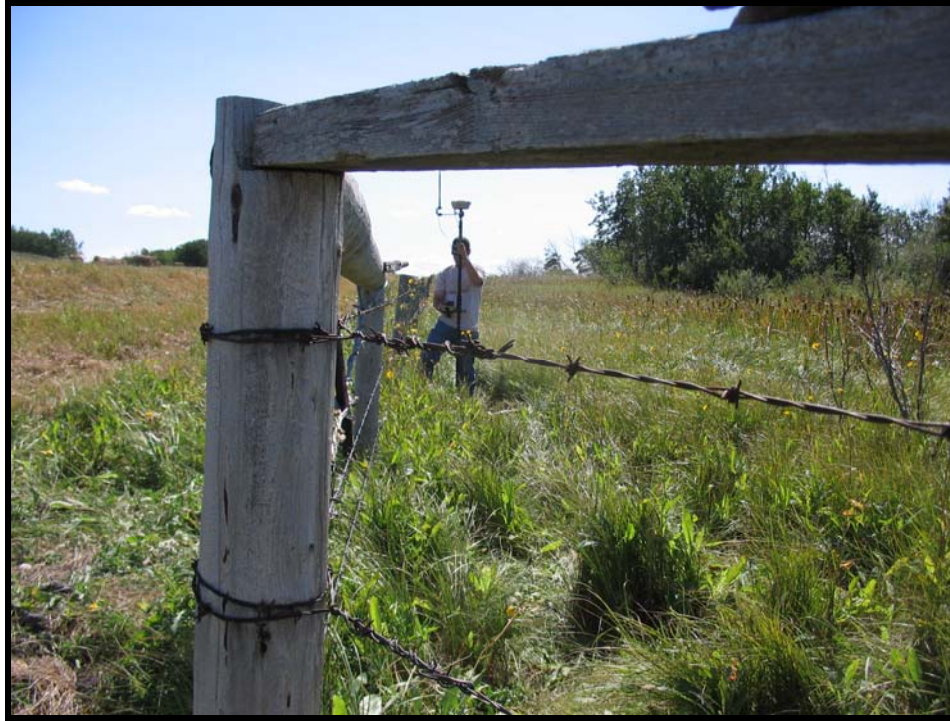
**Figure 3.7: Occupying the Witness Monument near NE 1-15-10 W2 Mer**

A couple of section boundaries were harder to establish than others. It took quite a while to find the witness monument along the east boundary of 1-15-10 (See Figure 3.7 below).

Originally, this witness was a mound and trench. In 1971, J.P. Scott (SLS) found this witness monument of a mound and trench and planted an iron post accordingly. Unfortunately, Mr. Scott's plan only connects to the witness monument with an angle and not a distance. At this point, it was decided to use township distance to calculate an estimated distance to the monument and look for remnants of a trench. The distance measured to a corner fence post which seemed appropriate. Long grass in the area was stamped down in hopes of walking into a trench or seeing a mound. This was to no avail. There was much wire and iron fence braces making the metal detector somewhat useless. A section corner was estimated using field lines in the area and 2.5 chains were paced

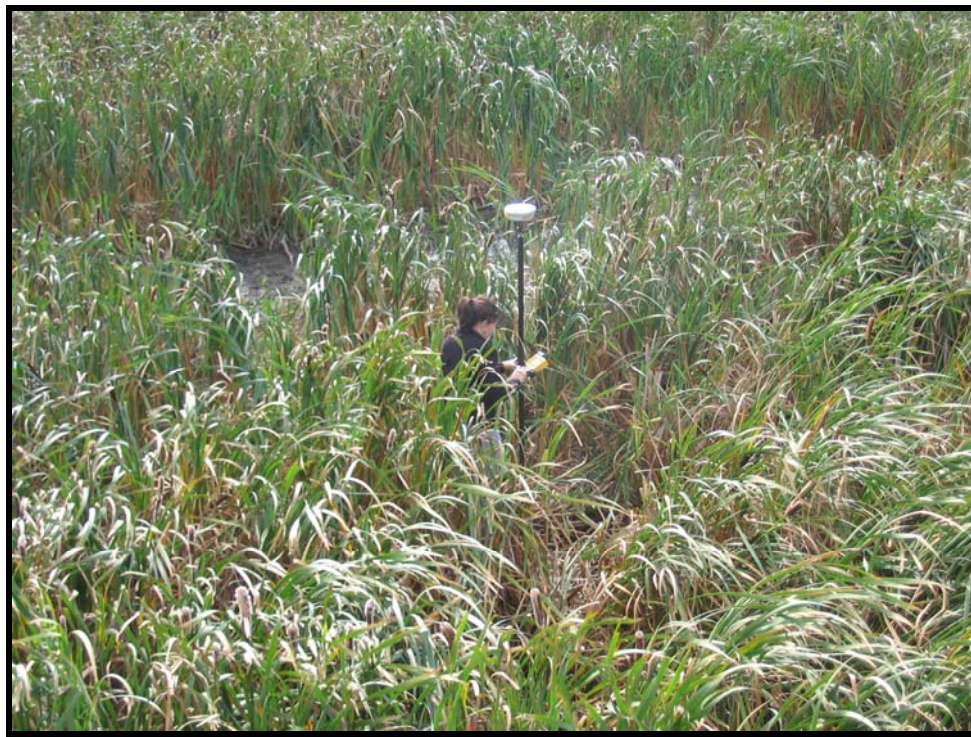
**Figure 3.8: Occupying the monument at the E 1/4 33-14-9 W2 Mer**

The second section boundary which was at one point impossible to find was the east quarter of section 33. Surprisingly enough, a deep slough was found to be in the same area the monument was calculated to be. Fortunately, the second trip to the area was in early September and the slough had dried up enough to find and occupy the monument (See Figure 3.8 below).
